Project name:  
Park Construction 1406

# Inspection report

Road: <b>Impex Hse, 8 Scrubbs Lane</b>	Division:	start MH: <b>MH1</b>
Place: <b>London, NW10</b>	District:	end MH: <b>Gully</b>
Location: <b>Warehouse</b>	Tape No.: <b>DVD</b>	Total length: <b>10.77 m</b>

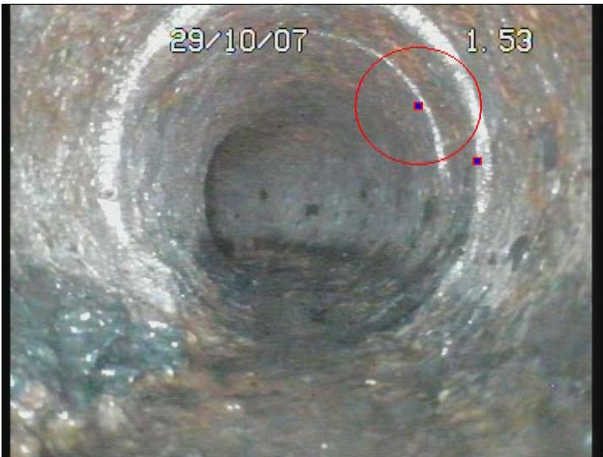
Photo: 5\_2a, Tape No.: DVD, 00:00:00  
1.5m, Circumferential Crack, from 12 to 03 o'clock

Comment: **Concrete cutting equipment is required**

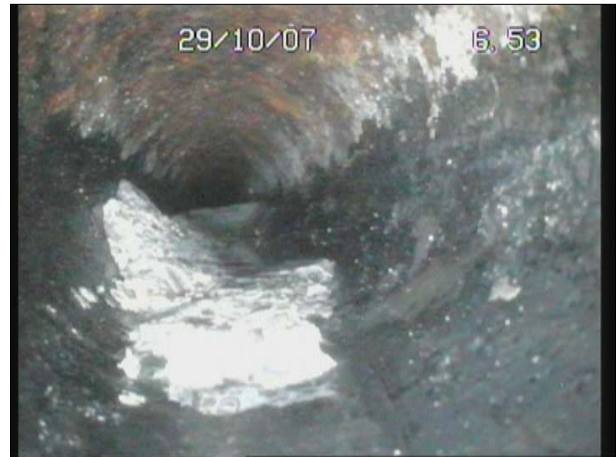
Photo: 20a, Tape No.: DVD, 00:00:00  
6.5m, Obstruction (Concrete/Tarmac), 40% cross-sectional area loss

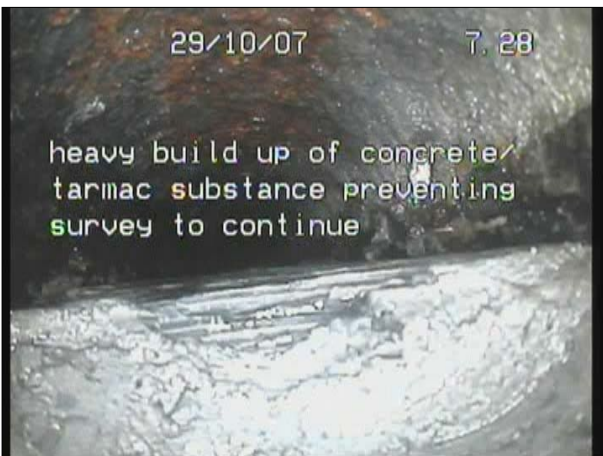
Photo: 21a, Tape No.: DVD, 00:00:00  
7.2m, Obstruction (Concrete/Tarmac), 50-60% cross sectional area loss

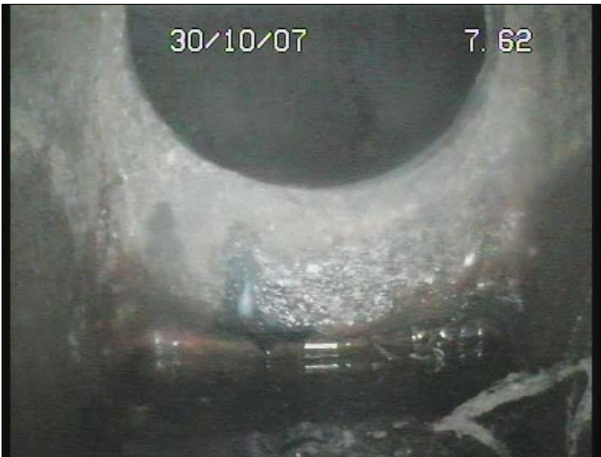
Photo: 36a, Tape No.: DVD, 00:00:00  
7.6m, Finish Survey, Remark: Possibly 100mm Stack pushed into 150mm Main Line

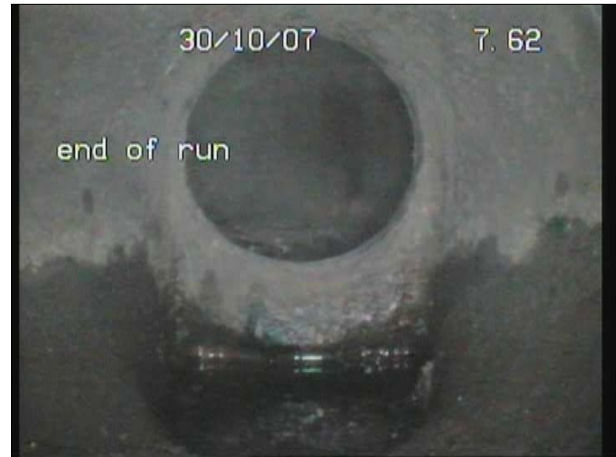
Photo: 36b, Tape No.: DVD, 00:00:00  
7.6m, Finish Survey, Remark: Possibly 100mm Stack pushed into 150mm Main Line

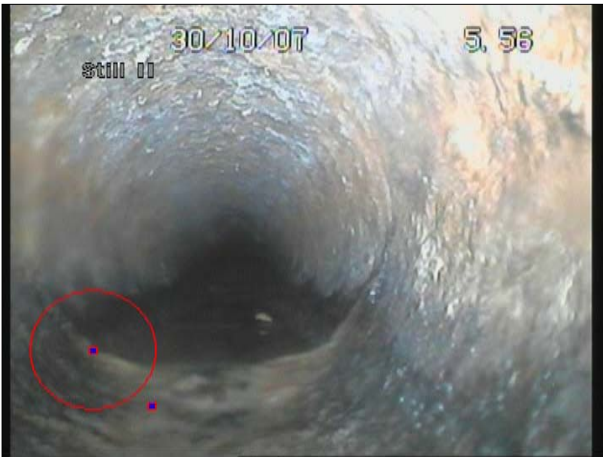
Photo: 14\_2a, Tape No.: DVD, 00:00:00  
5.5m, Joint displaced. Medium

Comment: **Pipe requires lining**

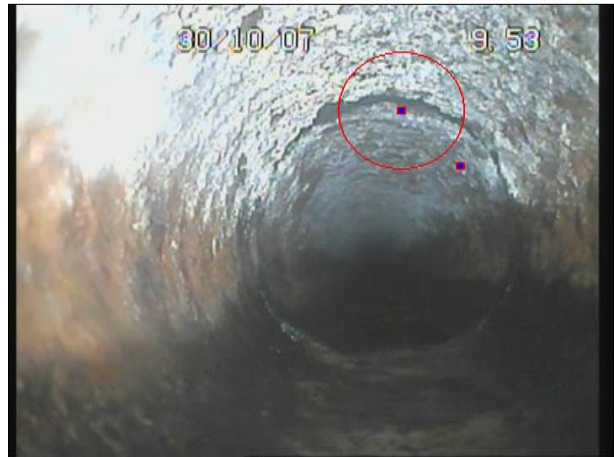
Photo: 14\_3a, Tape No.: DVD, 00:00:00  
9.5m, Joint displaced. Medium

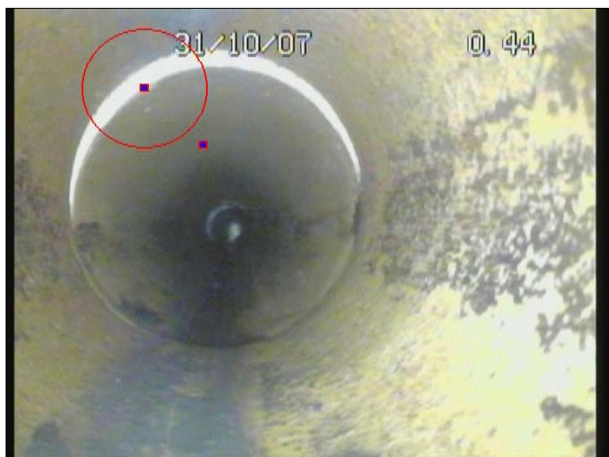
Photo: 24\_2a, Tape No.: DVD, 00:00:00  
0.4m, Joint displaced. Medium

Comment: **Pipe requires lining**

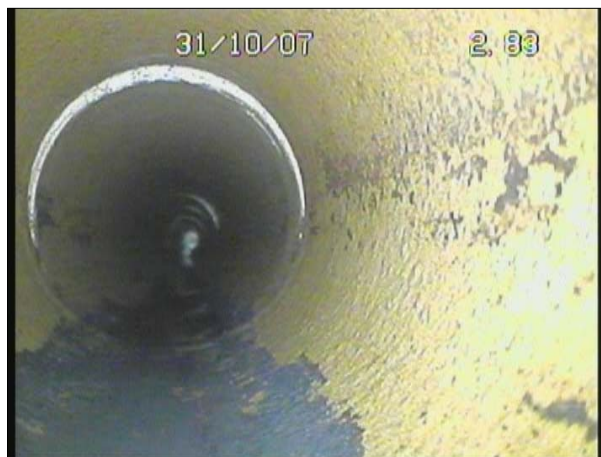
Photo: 77a, Tape No.: DVD, 00:00:00  
2.8m, Joint displaced. Medium

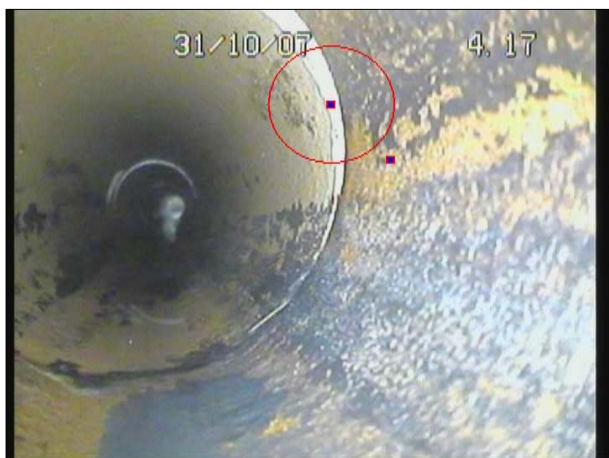
Photo: 24\_5a, Tape No.: DVD, 00:00:00  
4.8m, Joint displaced. Medium

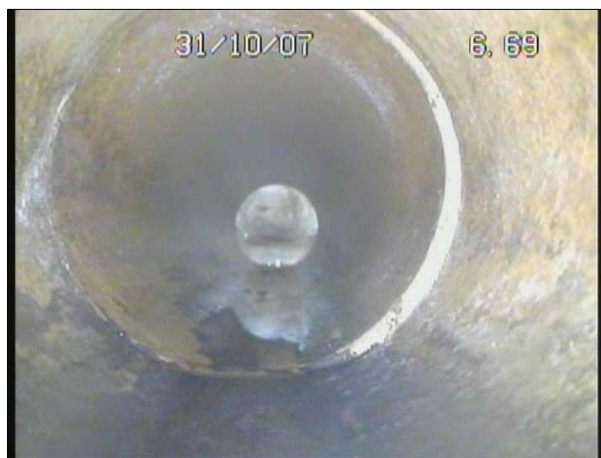
Photo: 79a, Tape No.: DVD, 00:00:00  
6.6m, Joint displaced. Medium

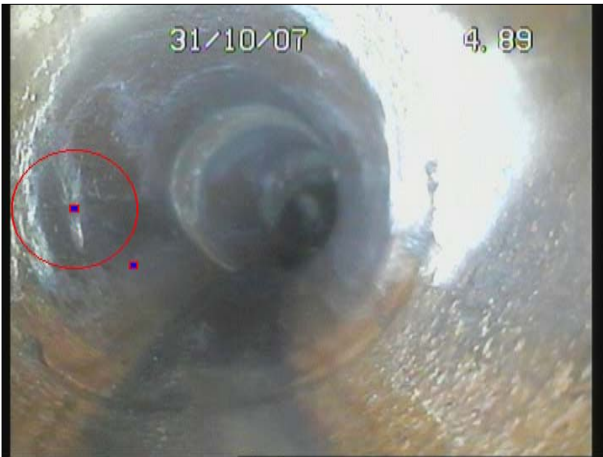
Photo: 25\_2a, Tape No.: DVD, 00:00:00  
4.8m, Longitudinal Crack, at 09 o'clock

Comment: **Pipe requires lining**

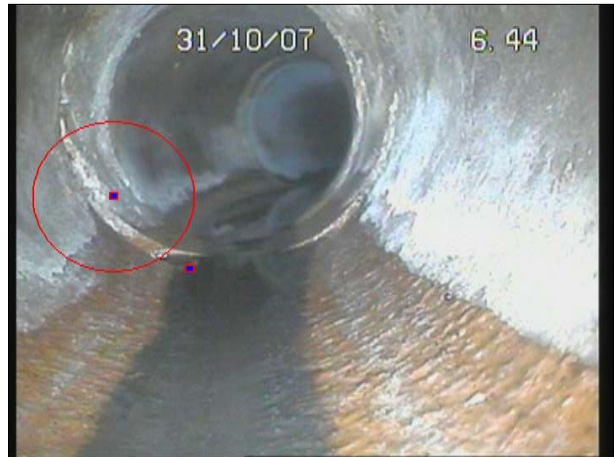
Photo: 25\_4a, Tape No.: DVD, 00:00:00  
6.6m, Circumferential Crack, from 03 to 09 o'clock

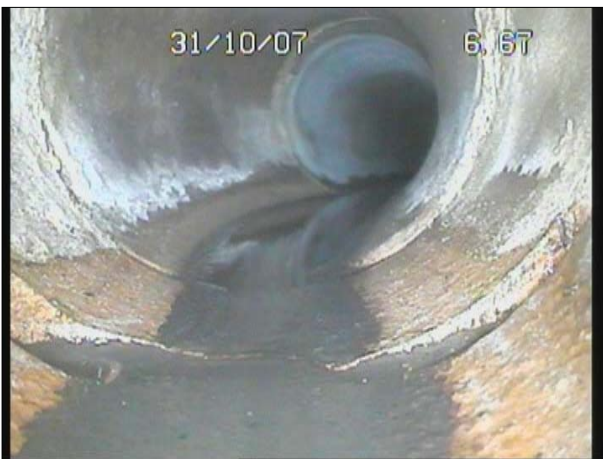
Photo: 85b, Tape No.: DVD, 00:00:00  
6.6m, Circumferential Crack, from 03 to 09 o'clock
