Project name :
CCTVSurveyReport2013

Contract Number :
11876

Date :
28/03/2013

Contractor **London Drainage Facilities Ltd**
 Contact Name: **CCTV Surveying Department**
 Department:
 Road: **PO Box 10412**
 Town: **Brentwood**
 County: **Essex, CM14 9GU**
 Telephone: **0800 612 2179**
 Fax: **0870 919 2179**
 Mobile:
 E-mail: **jobs@london-drainage.com**

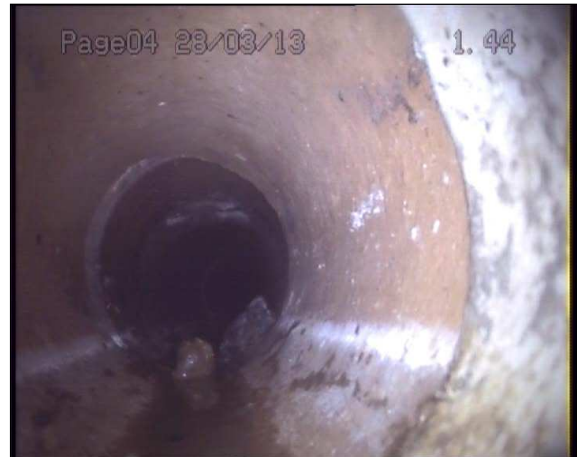
Photo: 1_1_4_A.jpg
1.9m, Sewer material changes

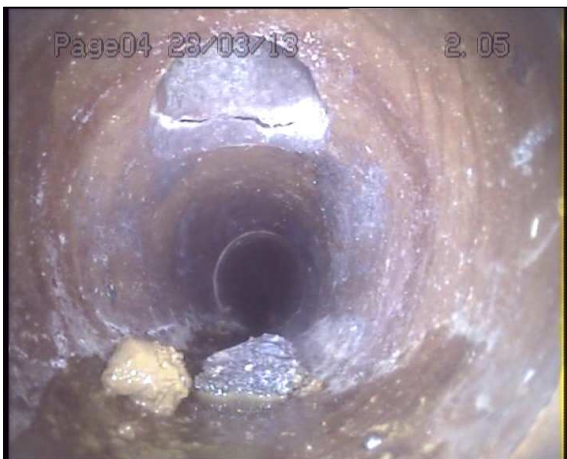
Photo: 1_1_6_A.jpg
2.1m, Connection, at 12 o'clock, 100mm diameter

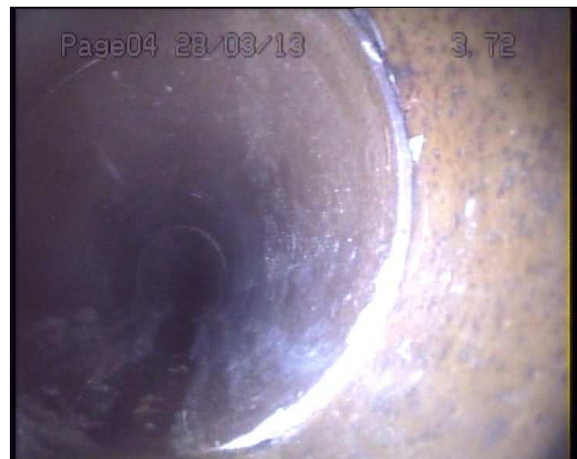
Photo: 1_1_7_A.jpg
3.8m, Joint displaced, medium (between 1.0 and 1.5 times the pipe wall thickness)

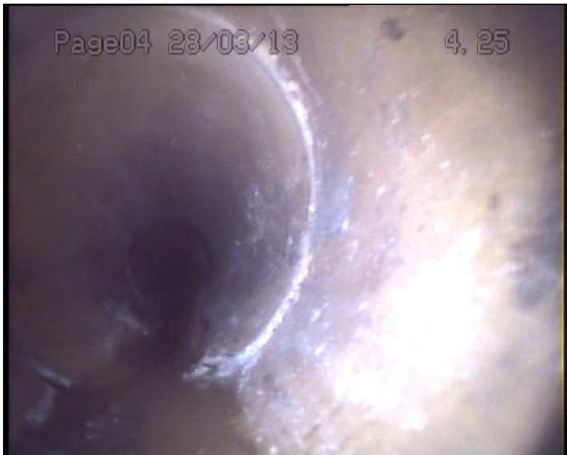
Photo: 1_1_8_A.jpg
4.4m, Joint displaced, medium (between 1.0 and 1.5 times the pipe wall thickness)

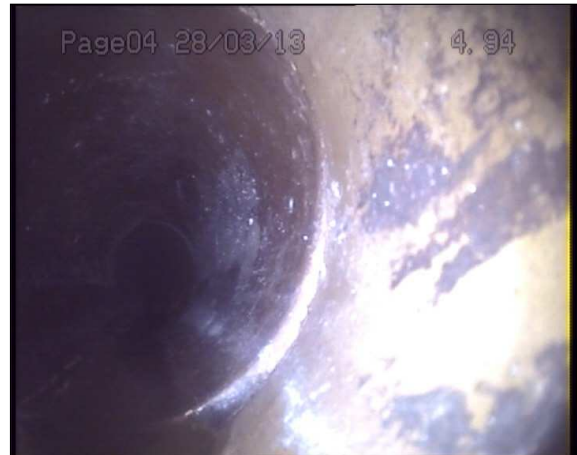
Photo: 1_1_9_A.jpg
5.1m, Joint displaced, medium (between 1.0 and 1.5 times the pipe wall thickness)

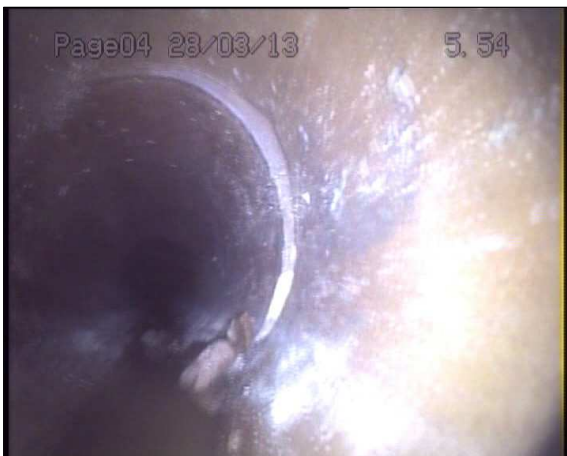
Photo: 1_1_10_A.jpg
5.7m, Joint displaced, medium (between 1.0 and 1.5 times the pipe wall thickness)

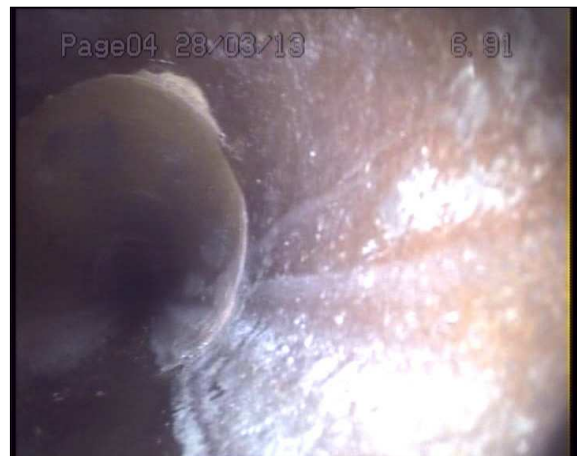
Photo: 1_1_11_A.jpg
6.9m, Joint displaced, medium (between 1.0 and 1.5 times the pipe wall thickness)

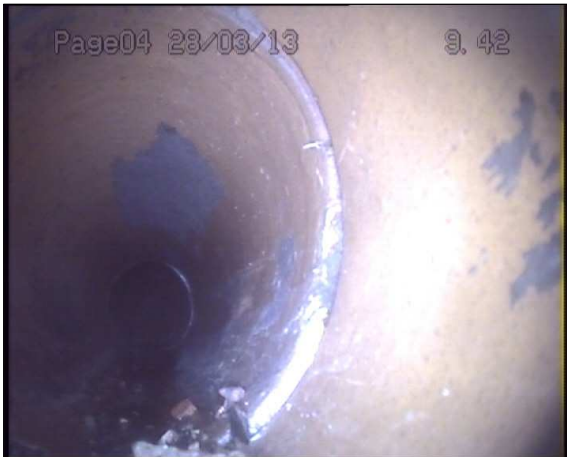
Photo: 1_1_12_A.jpg
 9.5m, Joint displaced, medium (between 1.0 and 1.5 times the pipe wall thickness)

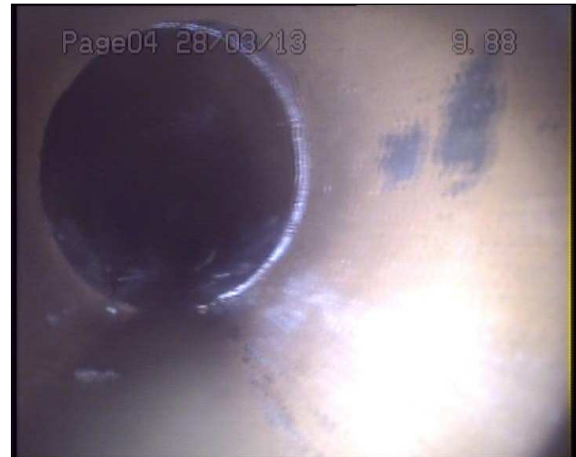
Photo: 1_1_13_A.jpg
 10m, Joint displaced, medium (between 1.0 and 1.5 times the pipe wall thickness)

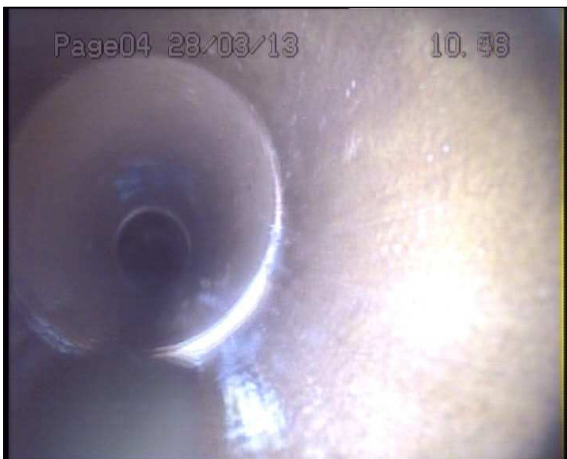
Photo: 1_1_15_A.jpg
 10.4m, Joint displaced, medium (between 1.0 and 1.5 times the pipe wall thickness)

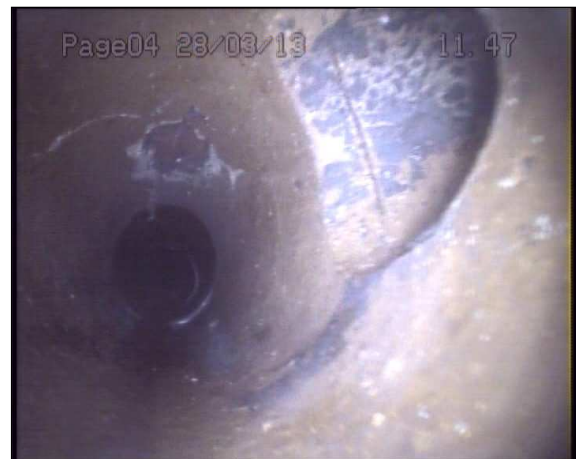
Photo: 1_1_17_A.jpg
 11.5m, Connection, at 3 o'clock, 100mm diameter

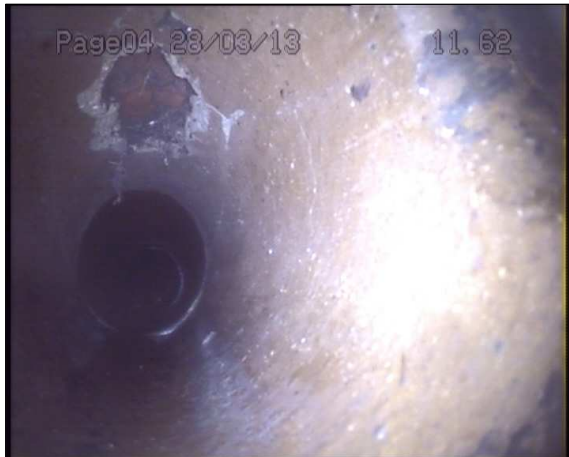
Photo: 1_1_18_A.jpg
 11.7m, Hole in sewer, from 12 to 1 o'clock

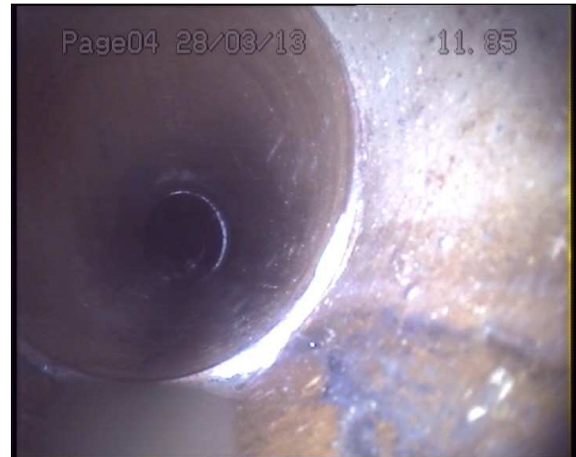
Photo: 1_1_19_A.jpg
 12m, Joint displaced, medium (between 1.0 and 1.5 times the pipe wall thickness)

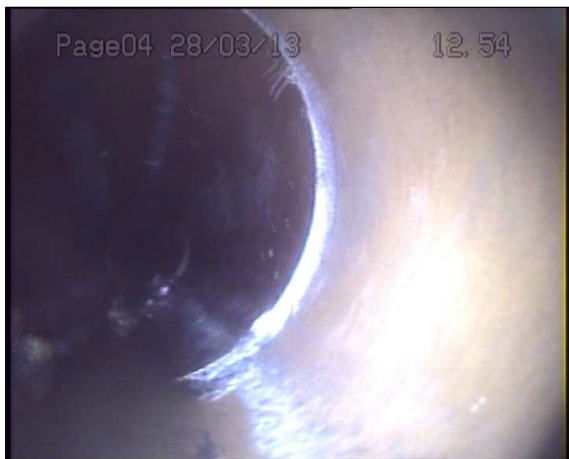
Photo: 1_1_20_A.jpg
 12.7m, Joint displaced, medium (between 1.0 and 1.5 times the pipe wall thickness)

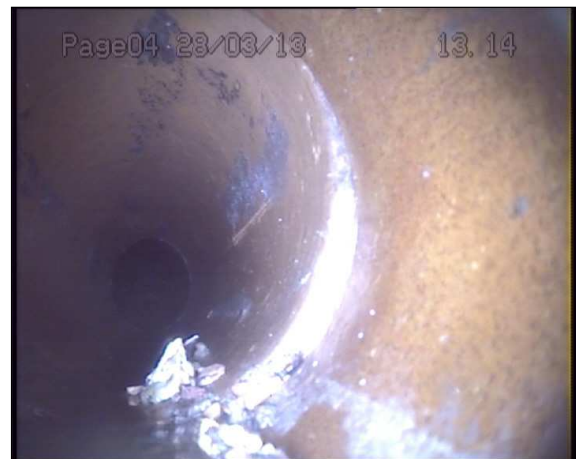
Photo: 1_1_21_A.jpg
 13.2m, Joint displaced, medium (between 1.0 and 1.5 times the pipe wall thickness)

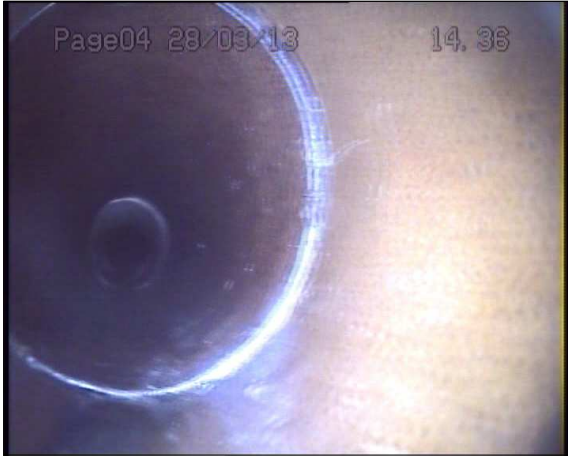
Photo: 1_1_22_A.jpg
14.3m, Joint displaced, medium (between 1.0 and 1.5 times the pipe wall thickness)

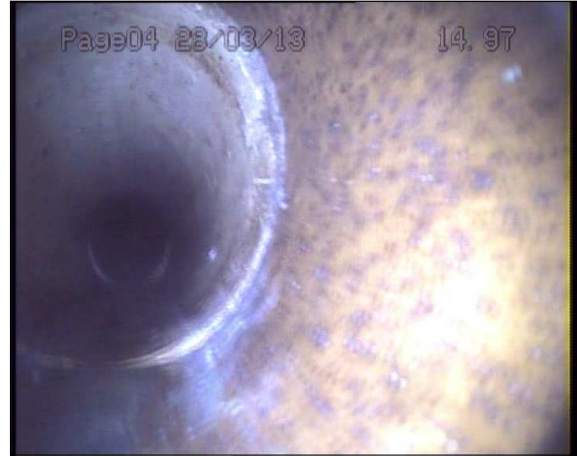
Photo: 1_1_23_A.jpg
15m, Joint displaced, medium (between 1.0 and 1.5 times the pipe wall thickness)

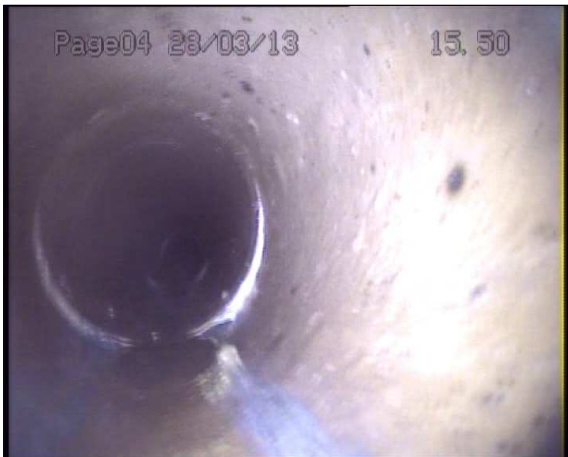
Photo: 1_1_24_A.jpg
15.6m, Joint displaced, medium (between 1.0 and 1.5 times the pipe wall thickness)

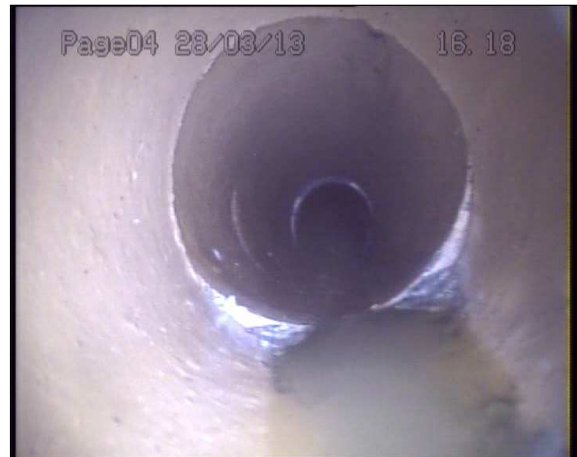
Photo: 1_1_25_A.jpg
16.1m, Joint displaced, medium (between 1.0 and 1.5 times the pipe wall thickness)

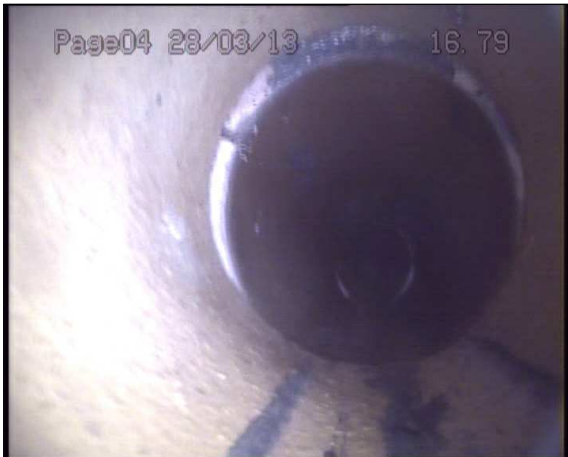
Photo: 1_1_26_A.jpg
16.8m, Joint displaced, medium (between 1.0 and 1.5 times the pipe wall thickness)

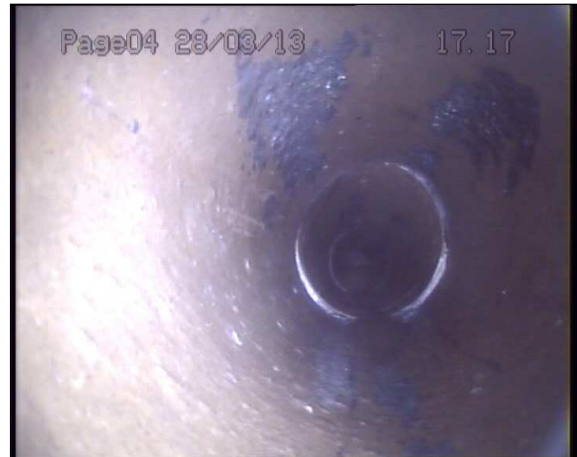
Photo: 1_1_27_A.jpg
17.1m, Joint displaced, medium (between 1.0 and 1.5 times the pipe wall thickness)

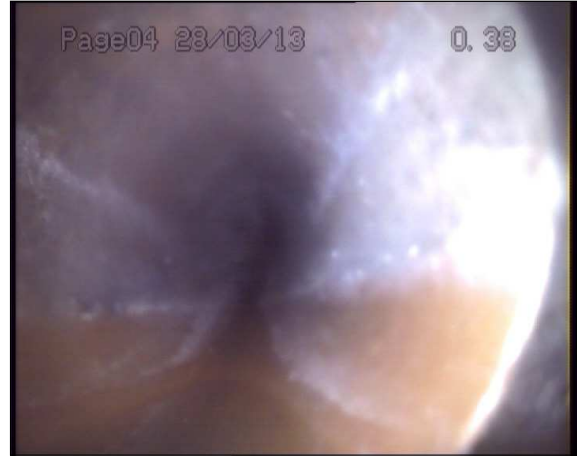
Photo: 3_3_31_A.jpg
0.3m, Shape of sewer changes at this point
